#### **HPT Data**

#### **HPT Log**

LCCS Reference Materials

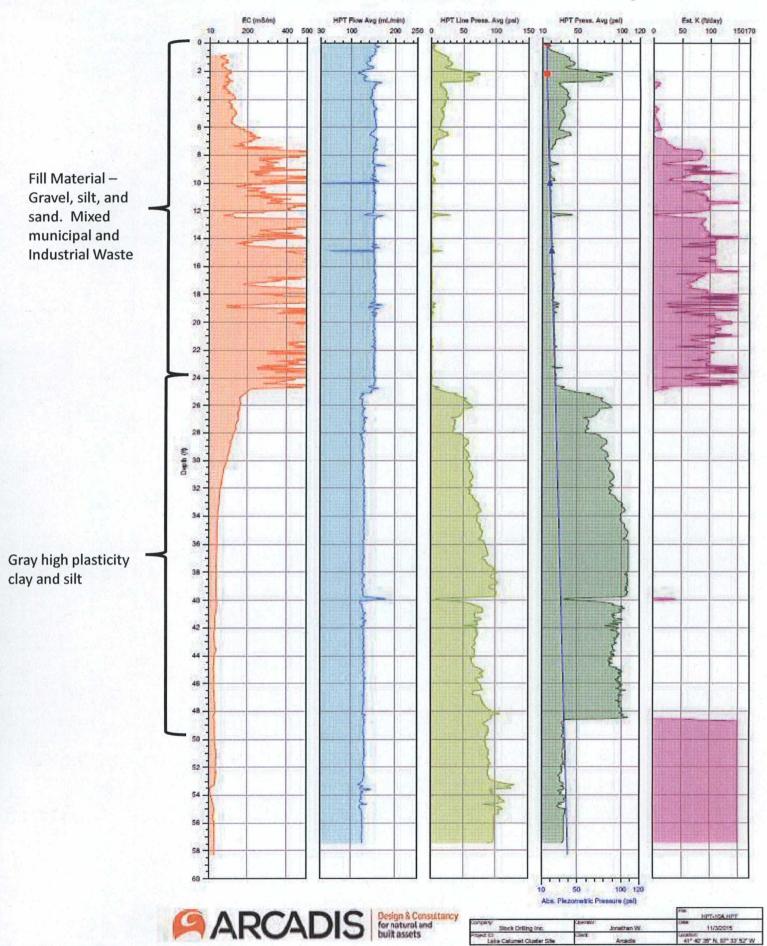
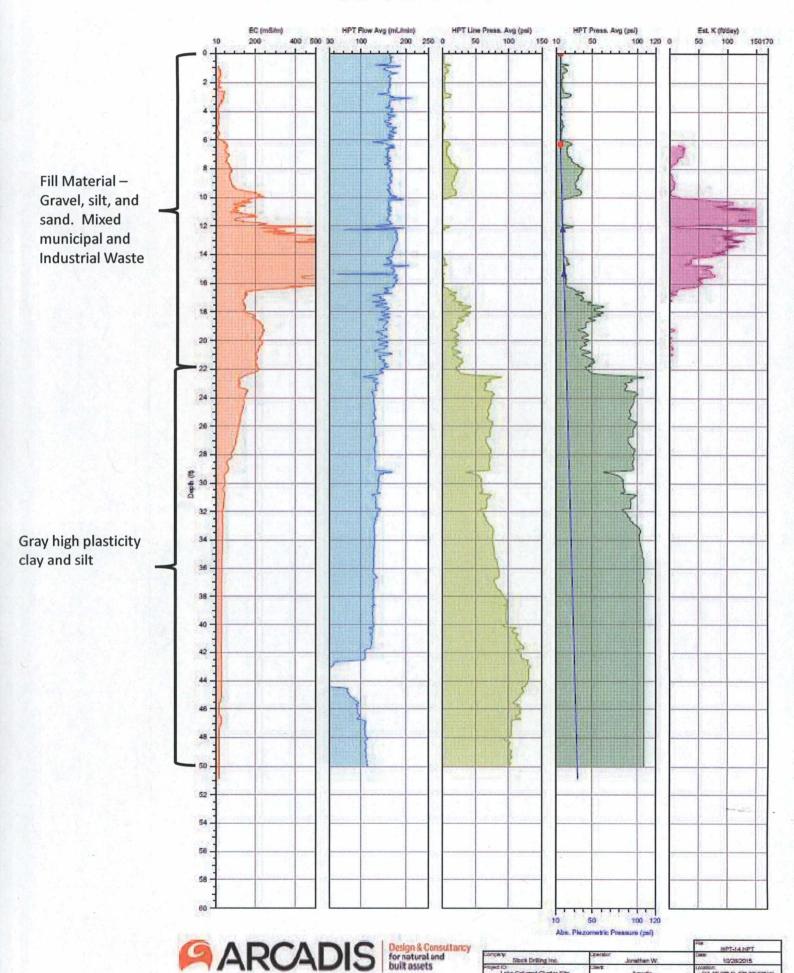
# SB-HPT-10A

The appearance of a higher-permeability unit in these logs is an artifact of a pressure sensor failure within the HPT equipment, and review of all the sensor data presented in the logs indicates that a permeable unit is not present at the depths in question. When HPT-01, HPT-10, and HPT-10A were completed in 2015, the Arcadis geologist noted that drilling conditions at these locations were more difficult than elsewhere on the Site, leading to greater wear on equipment. In particular, at location HPT-10, the drilling crew noted that the pressure sensor within the drilling tooling failed at a depth of approximately 48 to 49 feet below ground surface (bgs) and required replacement after the boring was complete. A second boring, HPT-10A, was attempted at an adjacent location to obtain more representative pressure data, but a similar sensor failure occurred. The pressure sensor failure resulted in a higher reported estimate of relative hydraulic conductivity on the HPT log, as shown below. The geologist determined that a unit with a higher silt content was present at these locations and depths, which was causing transducer failure and, thus, HPT logs that were not representative of the true geological conditions.

The attribution of this issue to the pressure sensor failure was confirmed through review of the "line pressure" sensor output on the HPT equipment to the downhole pressure reading on the HPT tooling. The line pressure and downhole pressure sensors both track hydrostatic pressure within the water injection line that runs to the downhole injection port and provide similar relative pressure readings when both sensors are functioning normally. In the case of HPT-01, HPT-10, and HPT-10A, a divergence in the two sensors' output is noted at depth, corresponding to failure of the downhole sensor.
